## Infrared roof inspection saves \$100,000

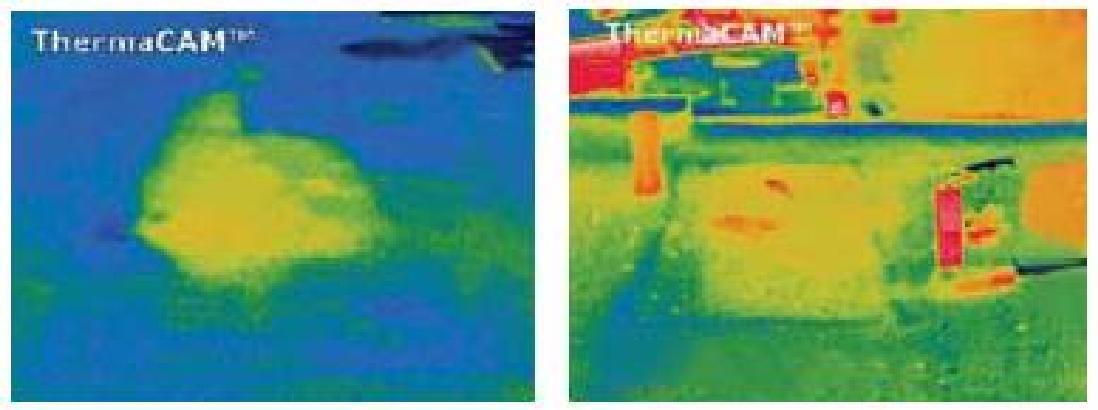
Sections of the 1200 square-foot wet area, which appear yellow in the infrared thermographs were torn out and replaced. The roofing system is a built-up type, consisting of a waterproof top layer of multiple coal tar pitch and modified bitumen plies with a pea gravel UV-reflective cover layer. The roof underlayment consists of 2 inch thick perlite on a steel deck substrate.
